Seismic Damage Assessment and Retrofitting of Hybrid Structure

ABSTRACT

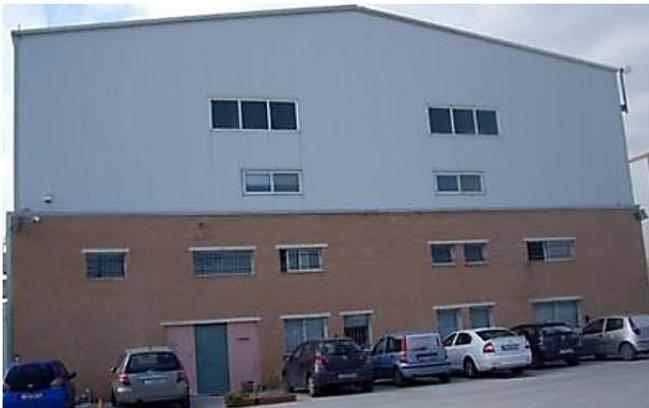
An example of a hybrid system with reinforced concrete frame at the ground floor level and steel frame above in Athens, Greece is shown in Fig. 1.

Fig. 1: Concrete-steel frame (Hybrid building)
<https://taxonomy.openquake.org/index.php/terms/hybrid-lateral-load-resisting-system-lh>

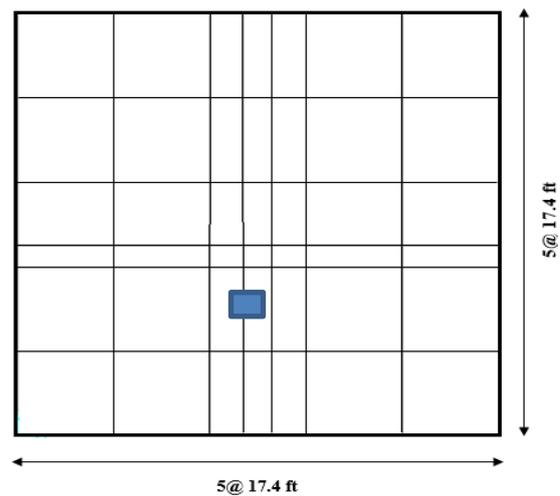
For computer modeling, a simple six storey hybrid building is selected. The building lies in occupancy groups A, B and I of BCP (2007) [15]. The plan area of building is 87×87 ft. with 11 ft. as height of each typical storey. It consists of top two stories steel frame with steel beam and column and the rest of four stories reinforced concrete frame. The connection to reinforced concrete frame to steel frame is considered as a rigid joint. The building is consisting of central elevator of concrete material having dimensions 5×5 ft. The plan area of the building consists of 5 bays both in X-direction and Y-direction. The total height of the building is 66 ft. The building is considered as a Special Moment Resisting Frame for both steel and RC frame with 6 inches thick slabs. RC Slab and shear wall were modeled as RCC shell elements. The plan of building is shown in Fig. 2. The sectional properties are given in Table 1.

Fig. 2: Plan of hybrid model building.

Sections	Width (In)	Depth (In)	Area (In ²)	Type
B 18×12	12	18	216	Concrete beam
B 20×14	14	20	280	Concrete beam
C 12×12	12	12	144	Concrete column
C 14×14	14	14	196	Concrete column
C 15×15	15	15	225	Concrete column
C 18×18	18	18	324	Concrete column
W12×14	11.8	4	4.16	Steel beam/column
W 14×22	13.2	5	6.49	Steel beam/column
W16×26	15.7	5.5	7.68	Steel beam/column
W18×35	17.7	6	10.3	Steel column
W21×44	20.7	6.5	13	Steel column
TS 4×4×1/4	4	4	16	Steel bracing

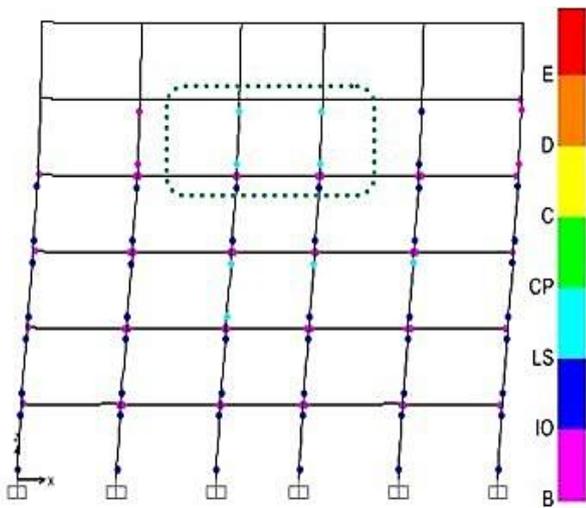
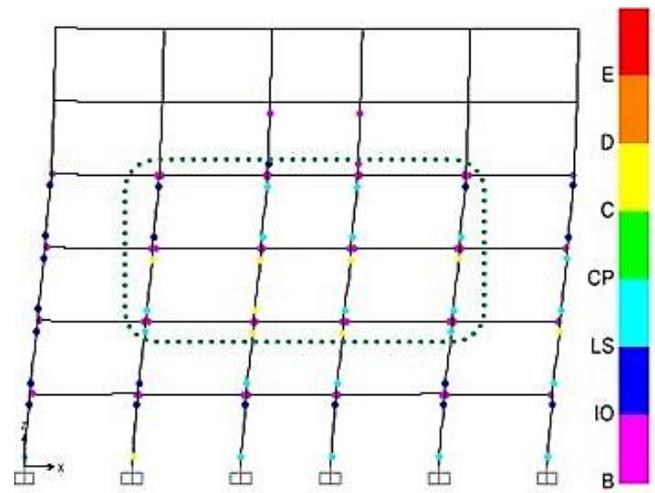
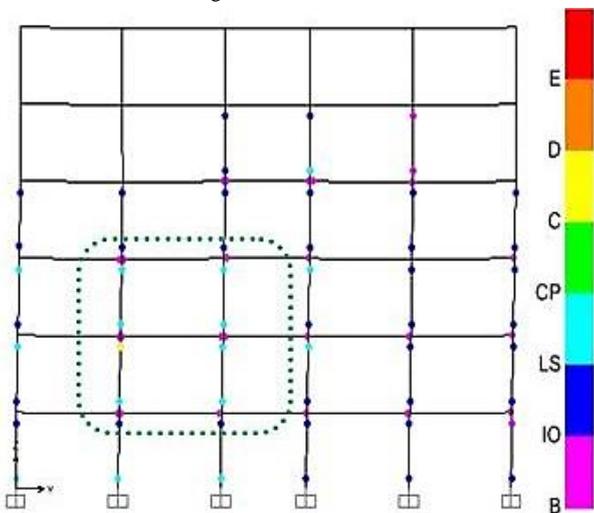
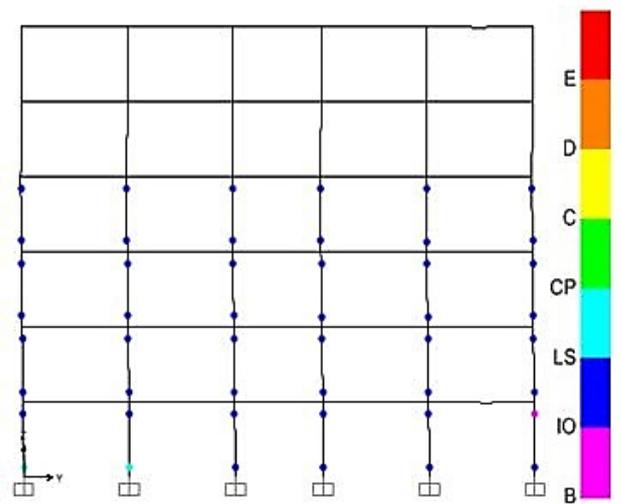
A simplified non-linear analysis provides relative qualitative data for the preliminary evaluation. The pushover analysis indicated hinge formations in the zone 3 of Pakistan, see Figs. 3 (a-d). It was observed that the majority of developed plastic hinges were at life safety and some of the hinges were at collapse prevention level indicating severe damage level to the model building. Plastic hinges at life safety and collapse prevention level were mostly found at the inter-storey column level of the RC frame. However, the hinges in steel columns at fifth storey were found at life safety level (North direction). The development of plastic hinges describes potential seismic damages that may lead to unacceptable performance of the building. These potential deficiencies can even lead to collapse of the structure and require appropriate retrofit intervention to improve the seismic behavior of the building.

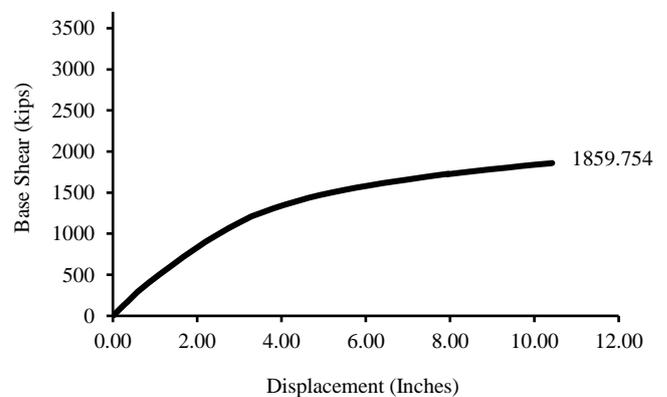
The capacity curve of the model building is shown in Fig. 4. The maximum lateral drift of the building recorded was 1.7% against the target displacement of 2.5% drift at a lateral load of 1859 kips. Quite low stiffness was recorded for the model building with lateral load at yielding of 1259 kips at a lateral displacement of 3.54 inches. The ultimate lateral displacement of 10.4 inches was recorded at a lateral load of 1859.8 kips. The building possesses considerable deficiencies in stiffness and ductility, and needs suitable retrofit strategy to increase the stiffness in order to reduce the excessive displacement.

Fig. 4: Capacity curve for 2.5% drift of model building.

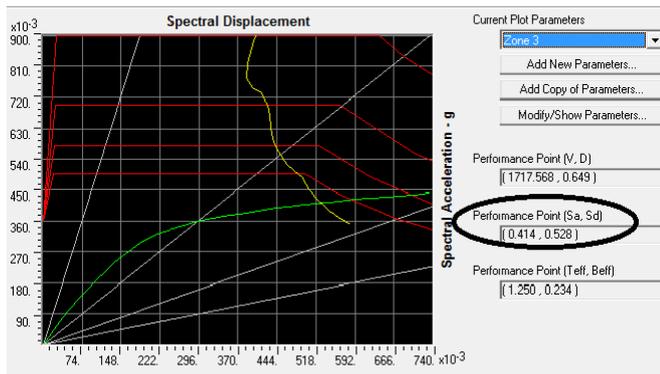
After pushover analysis, capacity spectrum curve was studied to determine different parameters. The building has sustained spectral acceleration of 0.41g and spectral displacement of 0.528 inch at performance point as shown in Fig. 5. High spectral acceleration clearly indicates that the building experienced high inertial forces and sustained considerable damages. The performance point occurred at a

lateral load of 1250 kips and lateral displacement of 2.81 ft. The performance point of the building lies between life safety and the collapse prevention, indicating considerable seismic damage potential in the building requiring appropriate seismic retrofitting.

Fig. 5: Capacity spectrum of model building.

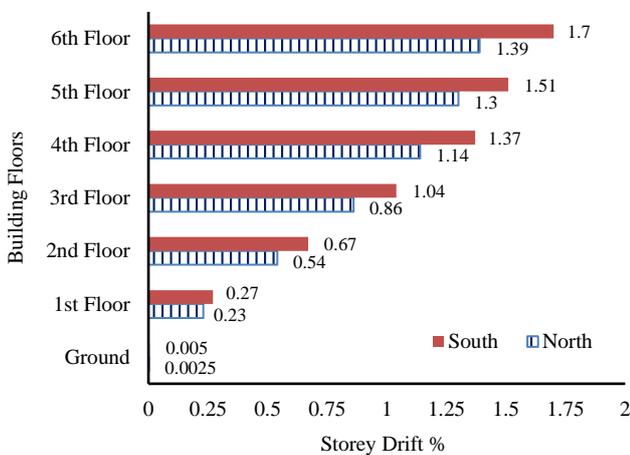
The recorded lateral storey drift of the building is summarized in Table 2 and graphical representation is shown in Fig. 6. It is found that the building has experienced a maximum storey drift at the top roof level which was about 1.7% in the southern direction and 1.39% in northern direction. These large displacements might lead the unacceptable performance level of the building as evident from the capacity spectrum. These unacceptable displacements can be controlled by adopting retrofit strategies which can reduce the storey drifts in the building. The seismic damage evaluation of the hybrid building revealed critical deficiencies in stiffness and energy dissipation which require an appropriate retrofit strategy for retrofit intervention. The required retrofit strategy must be based on improving the stiffness and deformation control phenomena so that the model building has enough capacity to withstand the seismic demand. The retrofit intervention and preliminary design are selected within the context of the selected strategy.

Fig. 6: Lateral storey drift ratios.

Building face	Storey drift (%)						
	G	1 st	2 nd	3 rd	4 th	5 th	6 th
North	0.002	0.2	0.5	0.8	1.1	1.3	1.39
South	0.005	0.3	0.7	1.0	1.4	1.5	1.7

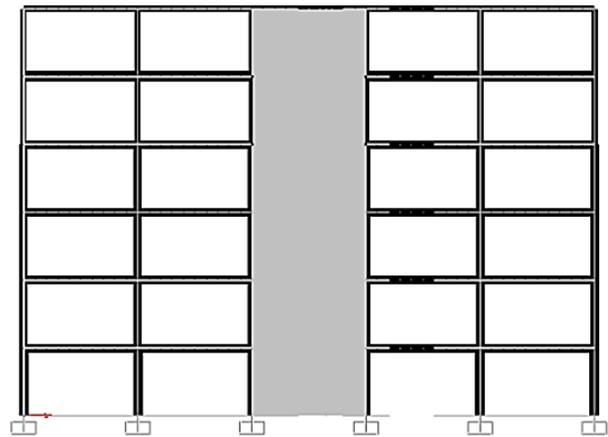
Fig. 7: Retrofitted with shear wall.

A retrofit system is the specific method used to achieve the selected strategy of retrofit. The deficiencies found in hybrid building needs improvement in strength, stiffness and ductility which can efficiently mitigate the observed seismic damages in the building. The retrofit system selected for hybrid building was “stiffness and strength”. Stiffening and strengthening retrofit strategy for the model building is typically accomplished by using the retrofit interventions like addition of braced members/shear walls. The hybrid building under consideration was strengthened by adding exterior shear wall throughout its height of the frame and by adding steel braces using ATC 40 Code [19]. In the 1st retrofit technique, the model building was retrofitted by adding shear walls to exterior side of the building in the center bay over the building height as shown in Fig. 7. The shear wall was added as a shell layer having a thickness of 12 inches. Whereas, in the 2nd retrofit technique steel braces were added at exterior side of the building in the center bay over the building height as shown in Fig. 8. For both the retrofit interventions pushover analysis was again carried out using same section properties/load cases and the retrofitted buildings were again evaluated for the seismic damage.

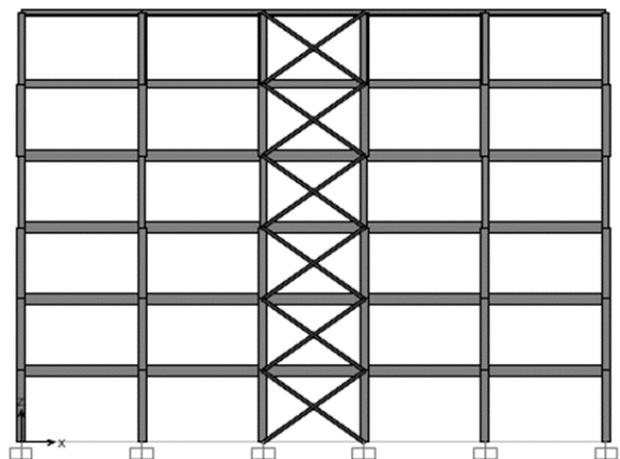
Fig. 8: Retrofitted with steel braces.

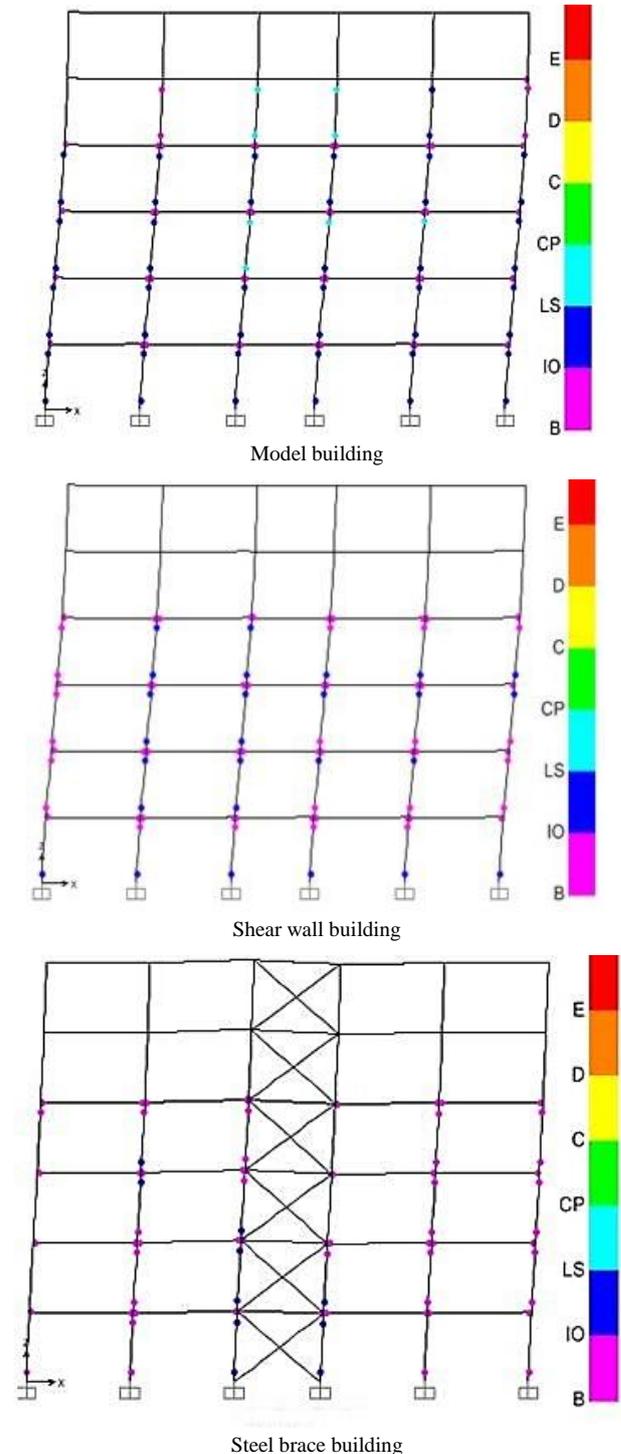
The comparison of plastic hinge development in the north grid is shown in Fig. 9. In the model building, plastic hinges were developed in all most all the beams/columns. It was observed that the majority of developed plastic hinges were at life safety and some of the hinges were at collapse prevention level indicating severe damage level to the model building. Moreover, plastic hinges were also developed at immediate occupancy/life safety levels in the steel columns at upper two stories. The plastic hinge formation improved significantly after retrofitting the building with shear wall. It was observed that plastic hinges developed in only few RCC columns/beams and the developed hinges were found at operational/immediate occupancy levels. No plastic hinges were developed in steel beams/columns at upper two stories and all the steel structural members remained elastic. In the case of steel braced building, large number of plastic hinges were developed in the RCC frame. However, all the developed plastic hinges were found within operational/ immediate occupancy level and none of the developed hinge crossed the life safety level. No plastic hinge was developed in upper two steel stories as was observed for building retrofitted with shear wall. Similar trend of plastic hinge development was observed in the southern direction (Fig. 10). In model building it was observed that the columns/beams in the RC frame were found at life safety and even collapse prevention level and plastic hinges were also found at 5th floor steel columns/beams. In the building retrofitted with shear wall, less number of plastic hinges were developed in RCC columns/beams and all the developed hinges were at operational level; whereas, no plastic hinge was in the steel frame. In the seismic zone 3 model building, the hinges in some cases have gone into collapse prevention level which is an unacceptable performance level, because it may cause loss of life and result in partial collapse of the building. The application of retrofit interventions in the developed hinges were found within operational/immediate occupancy level [23].

Fig. 9: Plastic hinge formation in north grid of Zone 3.

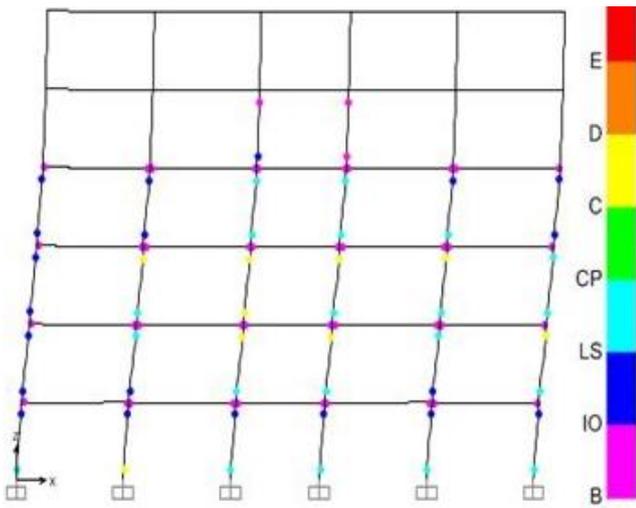
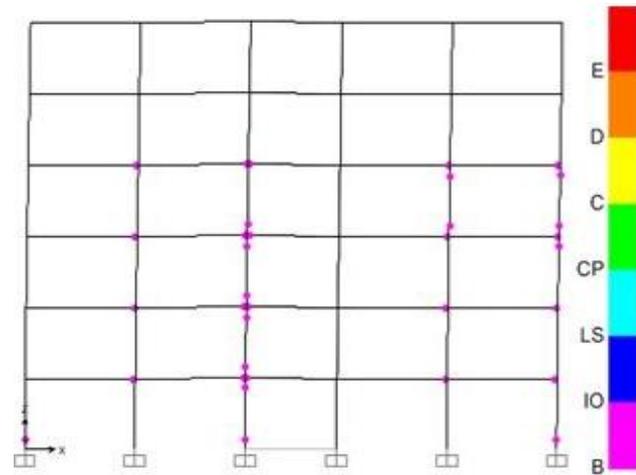
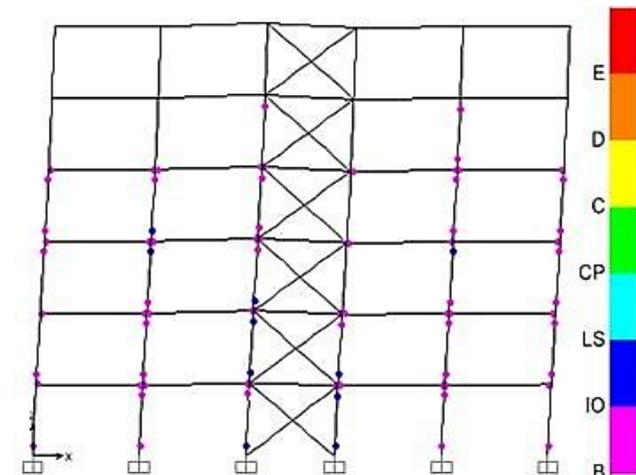
Model building

Shear wall building

Steel brace building

Fig. 10: Plastic hinge formation in south grid of Zone 3.

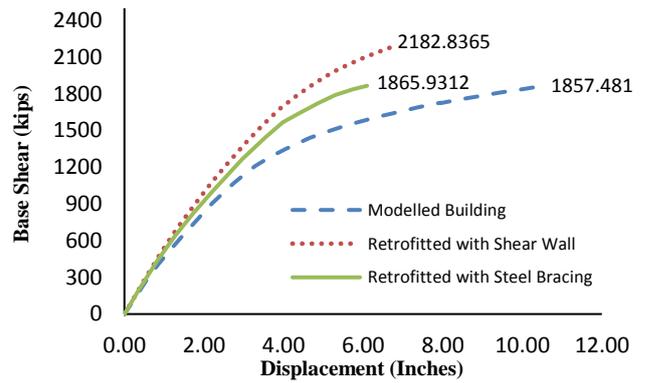
Fig. 11 shows the comparison of lateral load–lateral displacement relationship of the model and retrofitted buildings. Recorded value of base shear of model building is 1860 kips at a lateral displacement of 10.5 inches. After retrofitting with steel braces increase in base shear is very negligible; whereas, the decrease in lateral displacement is quite significant as compared to model building. The recorded value of base shear is 1865 kips at a lateral displacement of 6.1 inches. Retrofitting building with shear wall has significantly increased the base shear with reduction in lateral displacement due to increase in strength and stiffness caused by shear wall. The base shear value of 2182 kips was recorded

at a lateral displacement of 6.7 inches. It was observed that after retrofitted with shear wall the base shear of the building was increased significantly up to 15%, and retrofitting with steel bracing, the increase in base shear is about 1% which is considerably negligible. It was also observed that the lateral displacement of the retrofitted steel brace building and retrofitted with shear wall was reduced up to 36 % and 42%, respectively.

Fig. 11 Capacity Curves for 2.5% drift of Model Building and Retrofitted Building.

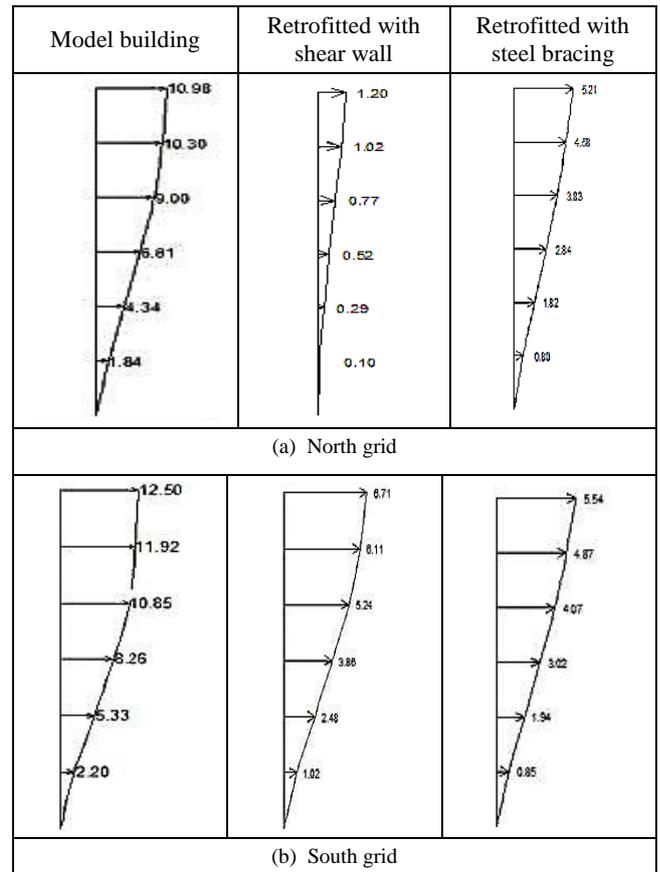
Model building experienced large displacements in north/south grids as shown in Fig. 12 (a and b). After retrofitting the model building with shear wall and steel braces, the maximum lateral displacements north grid was reduced by 90% and 52%, respectively. Hence, it is found that both the retrofit interventions are quite effective in controlling lateral displacements.

Fig. 12: Comparison of inter-storey lateral displacements of model and retrofitted building (values are in inches).

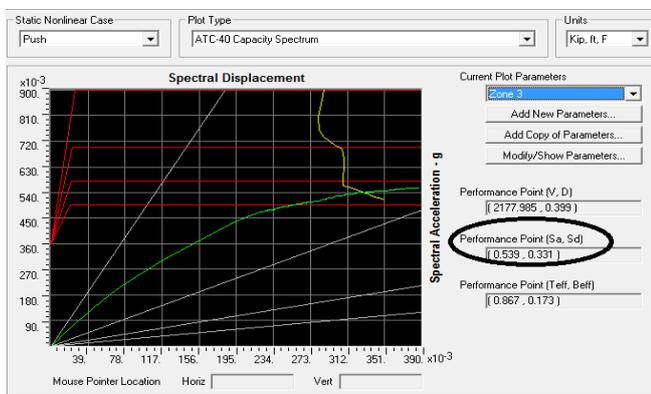
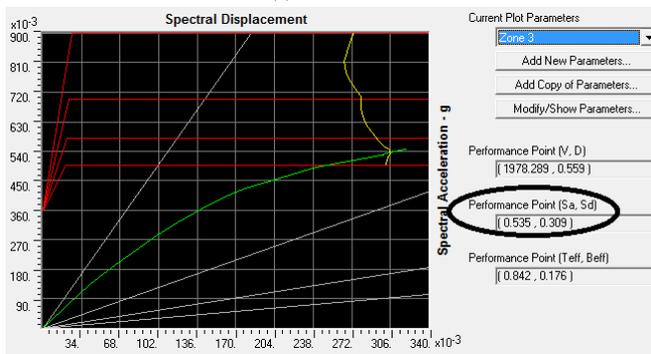
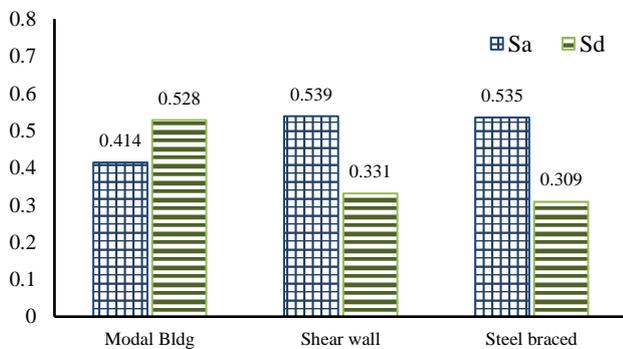
The capacity spectra of retrofitted buildings are shown in Fig. 13 (a and b). At performance point, the spectral acceleration (Sa) of 0.414g was recorded in case of original building as shown in Fig. 13c. After retrofitting with steel bracing and shear wall, building spectral acceleration increased by 23% and 22.6%, respectively. Similarly, spectral displacements (Sd) of buildings retrofitted with steel bracing decreased by 42% and in case of shear wall it came out as 37.5%. Overall the performance point improved considerably due to retrofitting and in both the cases lies in between IO-LS level. However, shear wall was more effective in improving the stiffness of building, while steel braces were comparatively more effective in improving the ductility of the building.

(a) Shear wall

(b) Steel braced

(c) Comparison of spectral acceleration (Sa) and spectral displacements (Sd) at performance point

Fig. 13: Comparison of capacity spectrum of retrofitted building.
